# NTK LAMBDA SENSOR NEWS

PNT-2015-008 -LS-Lambda Sensor damages by oil  
29.10.2015

### Lambda Sensor damages by oil

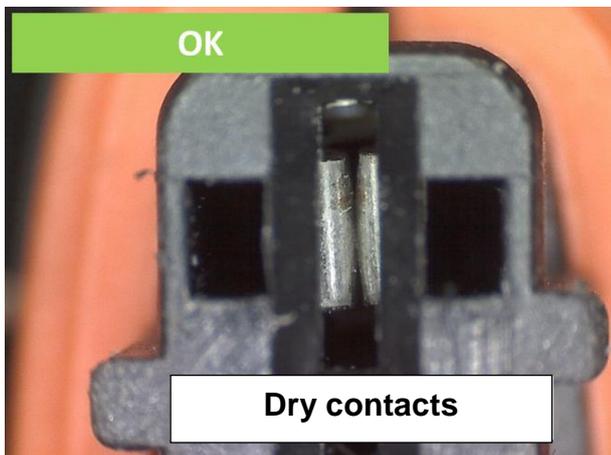
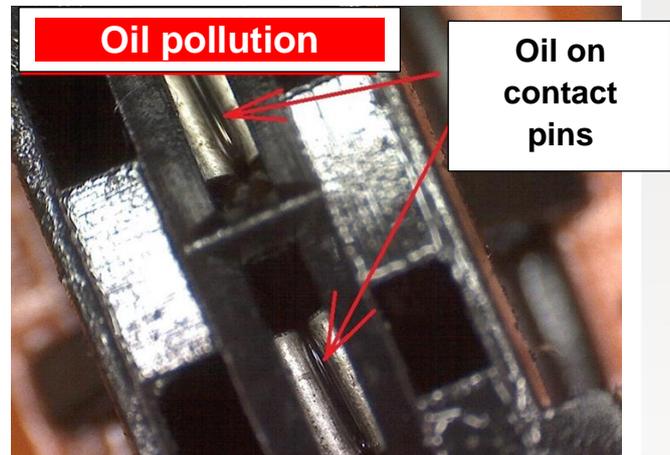
This can be achieved by a thoroughly visual inspection of the inside of the sensor connector. Even if the connector on a first glance seems to be completely dry, a careful visual inspection (a magnifying glass can help) often shows small oil traces on the electrical pins. A different method is to use absorbent paper : Touch the inner contact with this paper. *Even the smallest trace of oil is a sign of oil pollution.*

We know about the following sources of oil: Leaking oil pressure sensors, leaking camshaft control valves

Only exchanging the Lambda Sensor is not enough. The **source** of the oil must be identified and leakage must be stopped. Otherwise, after a short time period, the oil will be sucked through the wires of the new sensor, destroying this as well.
