The vehicle: Renault
Laguna 1.8L Petrol

The symptoms: Intermittent failure to start engine.

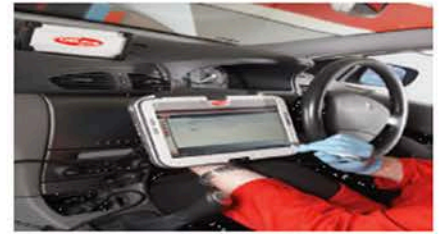
Fault returned: 'DF017 Flywheel signal sensor circuit, tooth signal missing – intermittent,' indicating a fault with the crankshaft sensor.

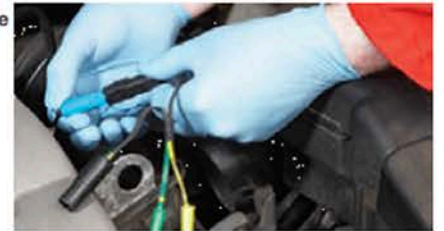
Step 4

In preparation for further interrogation with Delphi's PicoScope, the technician disconnected the crankshaft sensor from the harness and inserted a Delphi mini-bob (mini break-out box) between the two connections.

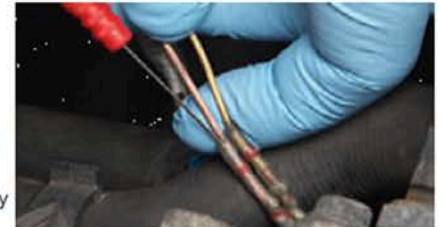
Step 6

The technician followed the easy to understand instructions, exclusive to the Delphi PicoScope software, to insert the PicoScope probe into the two pin test lead adaptor, otherwise known as the mini-bob (already fitted to the sensor connection).
