SERVICE PARTNER

Technical Information

CODING LIGHTING FUNCTIONS

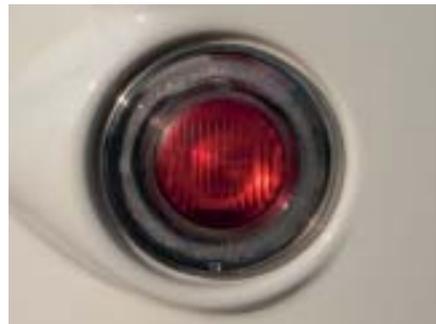
Fig. 13

When the light bulb is switched on, the air inside the light heats up. The expanded, heated and dry air is displaced out of the housing of the combination rearlight through the ventilation slits. After the light bulb has been switched off, the air in the combination rearlight slowly cools down again. This causes saturated humid air from outside to be “sucked” into the light interior. This can lead to condensation on the inside of the cover lens on account of high air humidity and greater temperature differences inside the light. This condition occurs more frequently in the cold months and in humid weather. If there is so much fogging that

water drops form on the cover lens (see Fig. 13) or water even accumulates in the lower area of the light (see Fig. 14), the seal should be checked for damage and replaced if necessary.

Equally, any “blockage” of the light ventilation openings should be checked. The light can be blasted with oil-free compressed air to dry it out. If water still accumulates in the light after this process, the light has to be replaced.

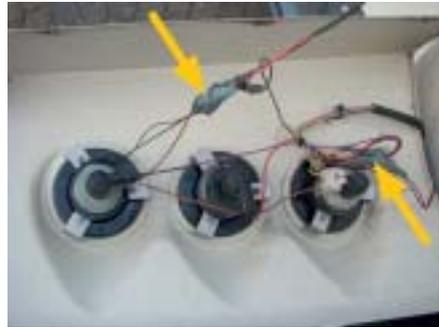
Fig. 15

effect. For the capillary effect to have any effect at all, water has to get into the cable. This is often due to a plug connection not being watertight. Simple blade connectors, incision-type connectors (current thieves) etc. do not offer the cable sufficient protection against humidity. This means that water can penetrate the cable through poorly or non-insulated cable areas under the cable sheathing (insulation) (see Fig. 15).

Through the capillary effect in the cable, humidity penetrates between the copper wires and cable sheathing into the light.

For this reason, watertight plug and cable connections such as Superseal plugs (see Fig. 16) should always be used.

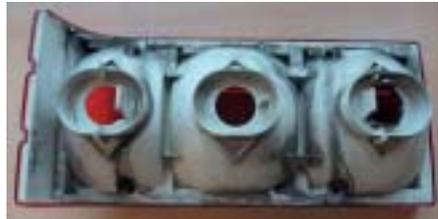
Failure of a lighting function is often the reason for a visit to the garage. In the case described here, the left stoplight and one side marker light have failed. The reason becomes obvious during dismantling of the lights. The combination rearlight is not sealed against the plastic body, so that there is nothing stopping dirt and water penetrating the light (see Fig. 17 and 18).

The bulb holder, the bulb sockets and the crimp contacts are corroded so heavily that they have to be replaced completely. In addition, the cable duct into the body is not sealed, so that water penetration has left clear traces here, too. For these reasons, a certain assortment of installation material is required for professional repairs. You can see a selection in Fig. 19.

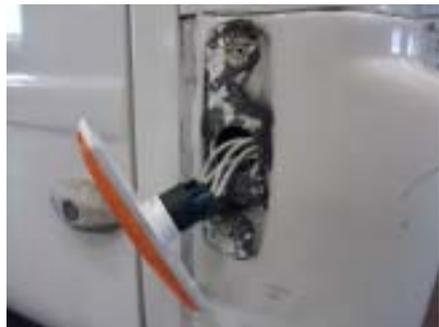
Fig. 22

The same problems can be seen after dismantling of the side marker lights. Here, sealing compound has been used generously in the past to prevent humidity penetration (see Fig. 22). Unfortunately, this measure was not successful.

The crimp contacts are completely oxidised, which in the end led to the light failing. Generally speaking, flush-mounted lights with fitted light bulbs should never be fitted or sealed using sealing compound or adhesive. If one of the bulbs were faulty, the light would be extremely difficult to disassemble, if at all possible. In such cases, the only solution is “complete reconstruction”!

1. Use a suitable cleaning agent to clean the contact face of sealing compound.
2. Pinch off old crimp contacts. Strip the cable ends to approx. 10 mm and fit crimp contacts e.g. HELLA no. 8KW 732 567-003. Then heat the shrink sleeves of the crimp contacts using a hot air gun until they are tight to the cable.

3. Clean the contacts on the lamp base or replace the lamp base if necessary.

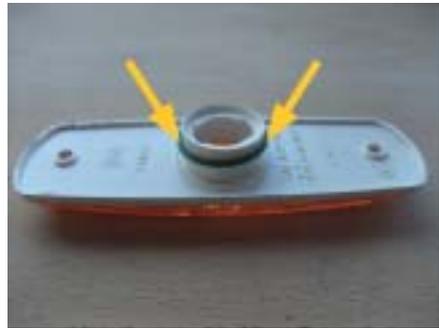
Fig. 23

This side marker light does not have a rubber seal to the plastic body. This means water can find a way between the body and the light housing in this case, too. This process is enhanced by the airstream. For this reason, O-rings should be used as seals for flush-mounted lights with a round light base. If there are no suitable O-rings available, have a look in your O-ring box for air-conditioning systems. Push the O-ring up to the light base plate (see Fig. 23).

Note! The O-ring must not be too thick. After assembly, the light should be flush to the body.
