Vauxhall Zafira B Model year: 2005 - 2009 With air conditioning

Recirculation air flap malfunction

BULLETIN

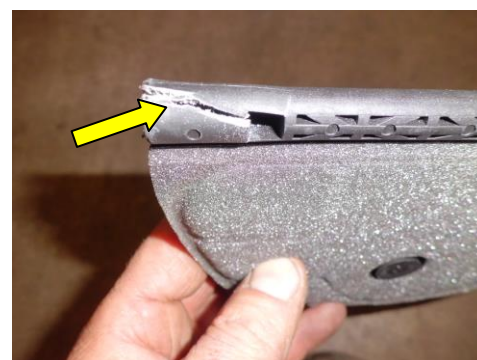
Figure 1

In the above vehicles, a damaged drive (Figure 1) between the recirculation air flap shaft and the recirculation air flap itself can lead to a malfunction.

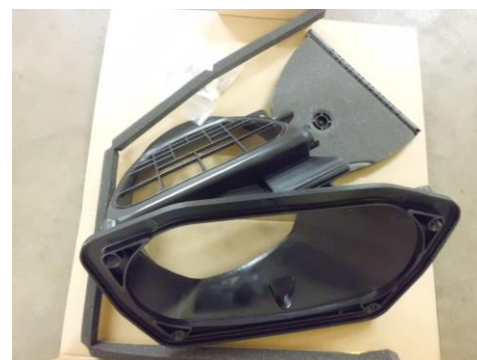
Figure 2

This can be remedied using a repair kit (93196653; Figure 2). This method involves installing a modified recirculation air flap housing and replacing the short shaft in the flap motor with a longer variant.

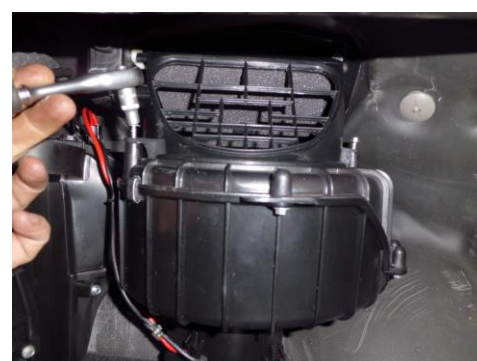
Figure 3

- Unscrew the fan motor from the recirculation air flap housing (Figure 3)
- Disconnect the recirculation air flap housing from inside the engine compartment
- Remove the housing

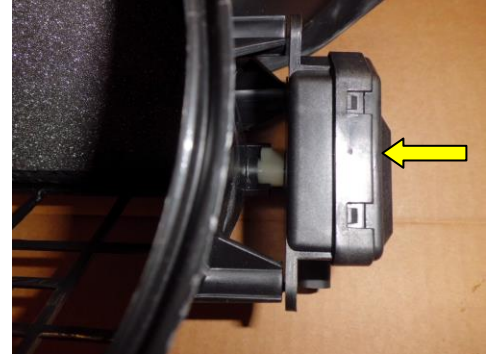
Figure 4

- Remove the recirculation air flap motor (Figure 4) from the old housing, together with the shaft

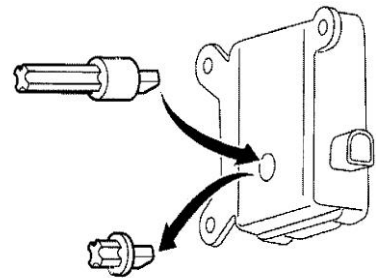
- Detach the short shaft and mount the long shaft from the repair kit (drawing)
- Mount the motor in the new housing, together with the shaft
- Install the recirculation air flap housing and fan motor

After conversion, a basic setting and functional test should be carried out.
