Getting to the heart of the problem

The focus of this article is on an Audi A4 (figure 1) which appeared at my workshop having had a new convenience ECU fitted. The garage that fitted and coded the convenience ECU wasn't the garage that diagnosed it. Worryingly, and this probably should have set the alarm bells ringing, the garage that diagnosed the ECU as being faulty, didn't have the capability to code the new ECU to the car (a simple variant coding procedure

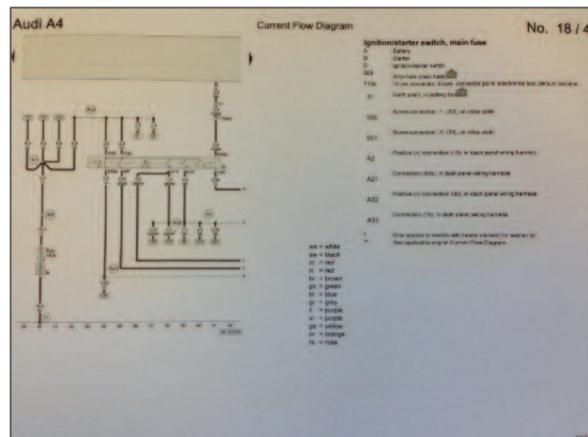
figure 2

Whilst looking through the diagrams (figure 2) it was confirmed that the body CAN connected several of the functions on the vehicle which were affected. Function chain analysis (understanding the way the car system should function, and what hardware elements are involved) is a key skill which we cover on our CAN Bus and in vehicle networking training course. By 'researching' the job before we attempt any testing (or stripping covers or components in order to test them) allows us to form a plan of attack; what, how, where and when to measure. Another guiding principle of fault finding (which we cover in electrical fault finding training) is that if you have made 5 measurements and haven't found the root cause – STOP! Technicians

munication fault (possible). The wiring diagram shows that the vehicle functions (which weren't working) are shared as data over the body CAN (network). Why did I choose network rather than power and grounds? Well, if the unit was turned off completely (through a bad power or ground), several of the things that did work (e.g. headlights) wouldn't have. So my function analysis and testing had ruled

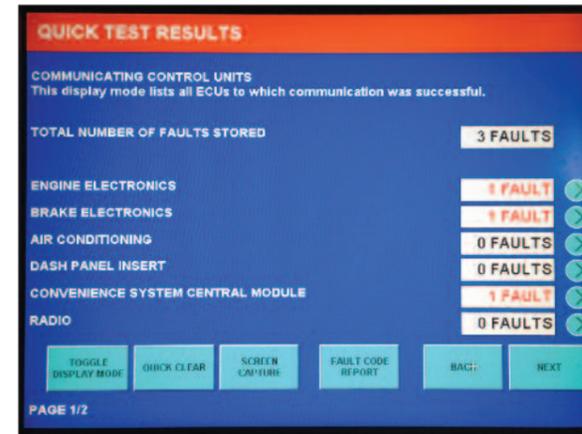
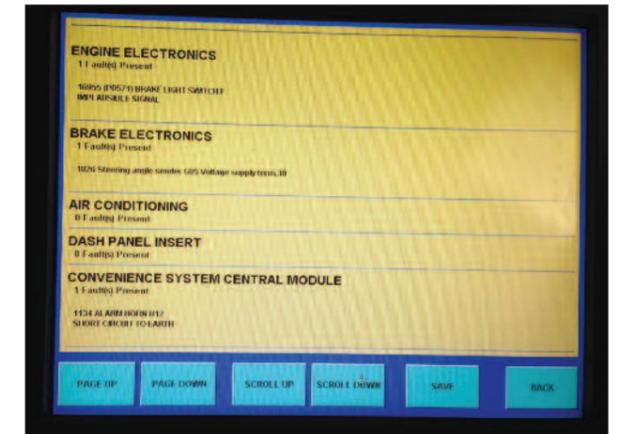
figure 3

certain failures out by virtue of what was still working. A global vehicle fault code scan showed 11 faults and some units with no communication (figure 3 & 4). The wiring diagram research showed that 'middle' of the

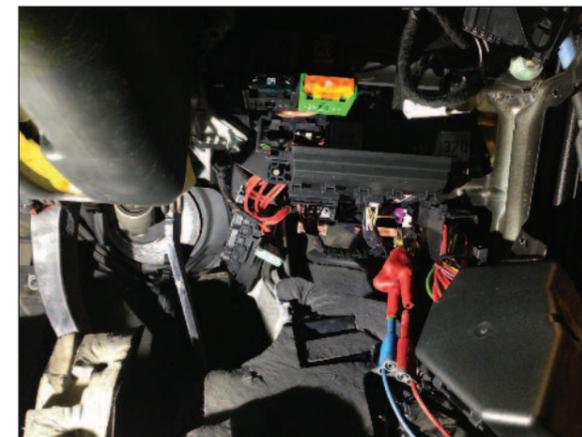
figure 5

circuit was the central electronics ECU. This component was also relatively straightforward to access by dropping the under dash panel (a few screws). Figure 5 shows the central electronics ECU exposed to the world.

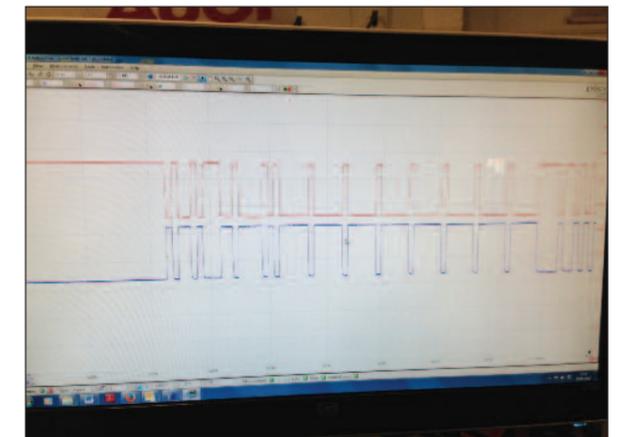
figure 6

signals was the oscilloscope. Connecting involved removing the plug cover and back probing the relevant wires. A quick check with the central electronics unit unplugged showed a perfect CAN signal (figure 6). Testing the wiring in this state, according to the layout of the CAN shown in the wiring diagrams, and getting a good signal, ruled out problems with the convenience unit and wiring, otherwise the signal would be affected regardless of the connection status of the central electronics ECU.

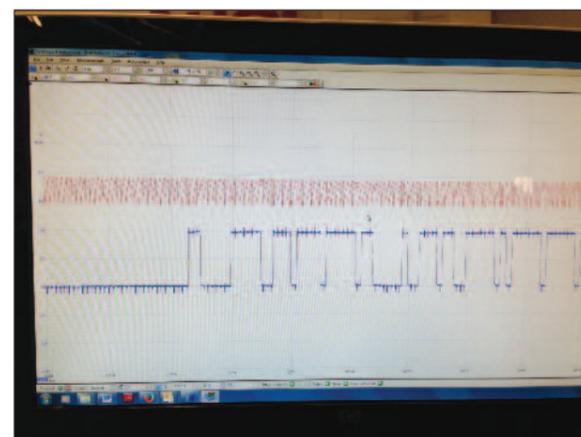
figure 7

function chain analysis (what worked and what didn't) and the structure of the wiring (what was connected where and in which order) and the data taken by the oscilloscope (one side of the bus affected), it was certainly not right and had to be corrected. Was it definitely the root cause of the problem? Probably. However, it's not always possible to declare that replacing a unit will absolutely fix

I plugged the central electronics ECU back in and saw the waveform in figure 7. One side of the network was being drastically affected by being connected to the ECU. Was this enough to condemn the ECU? Based on the combination data of

I discussed my findings with the customer and they authorised the purchase of a new central electronics ECU. It arrived the next morning, and once fitted the symptoms were fixed. A quick check of the CAN signals showed all was well electrically. The failed ECU was indeed the root cause of the problem. The customer was delighted to have the vehicle back in full working order.
