SERVICE INFO

VAG Wheel bearing removal

Manufacturers: Audi
Seat
Volkswagen

Model: A4, A5, A6, A7,
A8 Q5, R8
Exeo
Passat

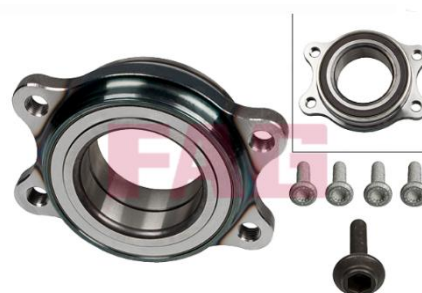
On the above vehicles the wheel bearing assembly can become seized within the aluminium suspension unit. This is due to a difference in composition between the arm and carrier, also known as galvanic corrosion. This is often overcome by force which can fracture the wishbone or damage the steering knuckles and ball joints.

Tools are available in the aftermarket to ensure these bearing assemblies can be removed without causing damage to the associated parts. The tool shown is a Sykes-Pickavant version.
